PROBLEM Solution

Project:
Microwave Cable Spool

System:
EnviroLastic® AR 200HD

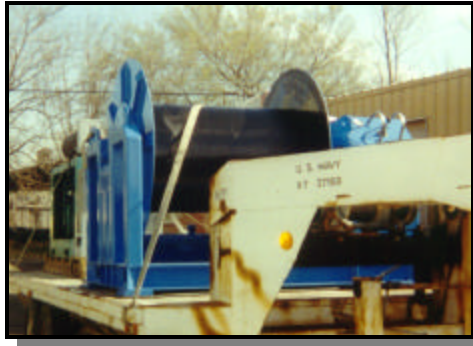
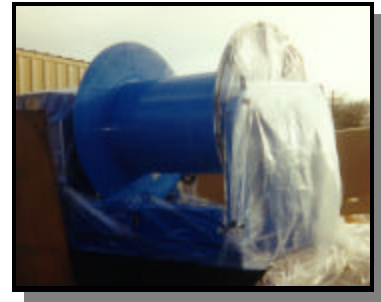
The cable spool was being used for experiments at extreme voltages through a coaxial cable for sonar transmissions. The voltages were short bursts of 30,000 volts plus.

The problem in their experiments came from damage to the cable sheath by the spool. With the high voltages being sent through the cable, any damage to the sheath would cause a loss in the voltage. Faulty results were noted and the experiments could not be completed.

Rather than using a more expensive sheath system on the cable, they chose to evaluate the possibility of coating the metal spool to prevent damage to the cable sheath. The solution was to spray the inner spool area with 130 mils of the EnviroLastic AR 200HD system.

Even though the spool was coated to protect the cable sheath from being damaged, spark testing was done using voltages in excess of 30,000 volts on the coated spool with no damage or coating failure. The spools were coated and shipped back the same day and are still in excellent service.
