Project:
WATER RETENTION BASIN

Owner:
Durand Glass Manufacturing Co., Inc.
Millville, N.J.

Installer:
Gombert Industries, Inc.

System:
EnviroLastic® AR 425

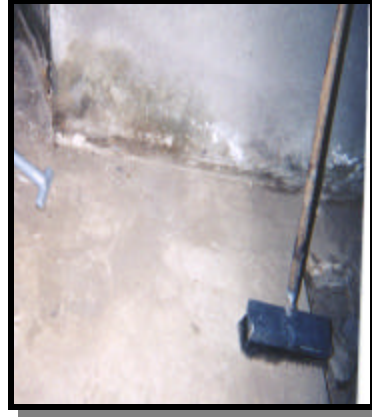
On site engineers at Durand were troubled by water leaking from the retention basin under their glass molding equipment. The basin is designed for emergency dumping of hot, molten glass should there be any problems on line.

After doing some research, Durand contracted a coatings installer to apply a polyurea coating to the walls and floor. The coating didn't cure due to the off-ratio mixing, and failed in several areas as soon as water was reintroduced.

Durand then called Gombert Industries Inc. to remove the failing materials, properly prepare the surfaces and install EnviroLastic AR 425. The basin was filled 2 days after coating completion and is holding tight as expected.
